**Flood Control Project Maintenance
Levee Inspections**

Fall 2010 Levee Maintenance Deficiency Summary Report

Sacramento River Basin

Sutter Maintenance Yard Maintenance Area 0016

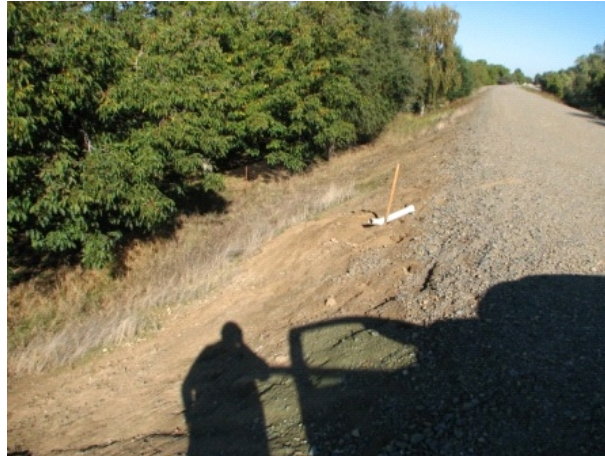
rduffey_f_20101110_278.jpg

Levee Mile Report Line	1
Start Levee Mile	0.01
End Levee Mile	0.01
Location	Land Side
Category	Earthen Levee
Item	Animal Control

View of squirrel holes along the slope.

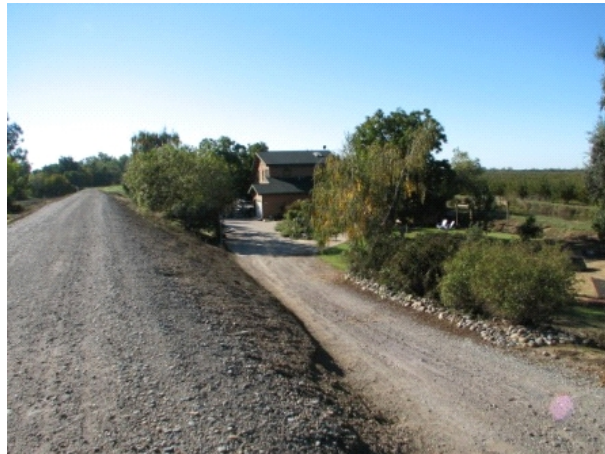
rduffey_f_20101110_279.jpg

Levee Mile Report Line	2
Start Levee Mile	0.06
End Levee Mile	0.10
Location	Land Side
Category	Earthen Levee
Item	Encroachments

Land side levee mile 0.10.

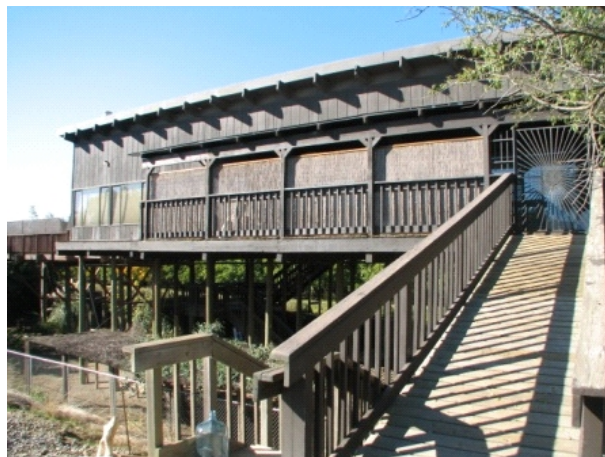
rduffey_f_20101110_280.jpg

Levee Mile Report Line	3
Start Levee Mile	0.18
End Levee Mile	0.18
Location	Land Side
Category	Earthen Levee
Item	Encroachments

Land side levee mile 0.18.

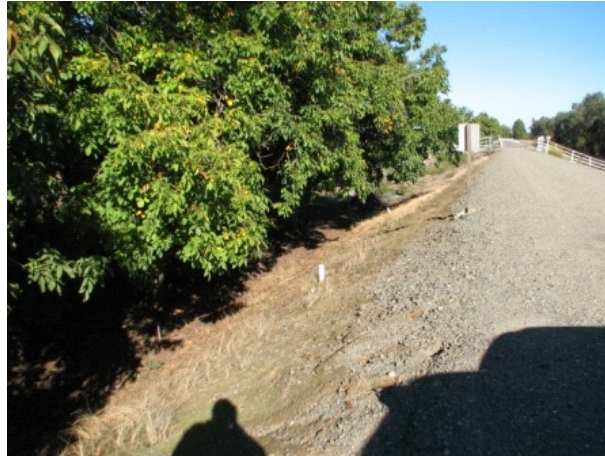
rduffey_f_20101110_281.jpg

Levee Mile Report Line	4
Start Levee Mile	0.21
End Levee Mile	0.25
Location	Land Side
Category	Earthen Levee
Item	Animal Control

View of squirrel holes along the slope.

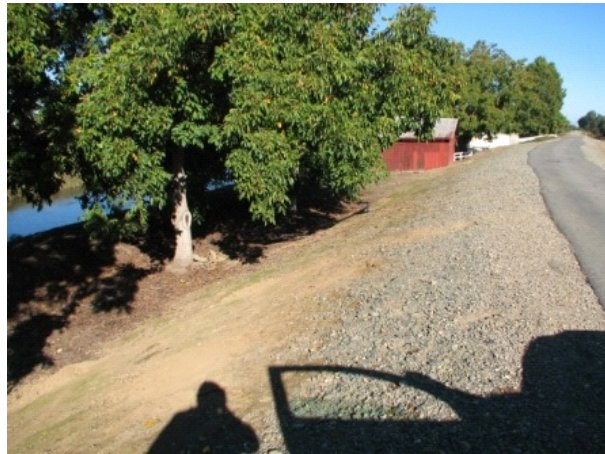
rduffey_f_20101110_282.jpg

Levee Mile Report Line	5
Start Levee Mile	0.39
End Levee Mile	0.39
Location	Land Side
Category	Earthen Levee
Item	Animal Control

View of squirrel hole along the slope.

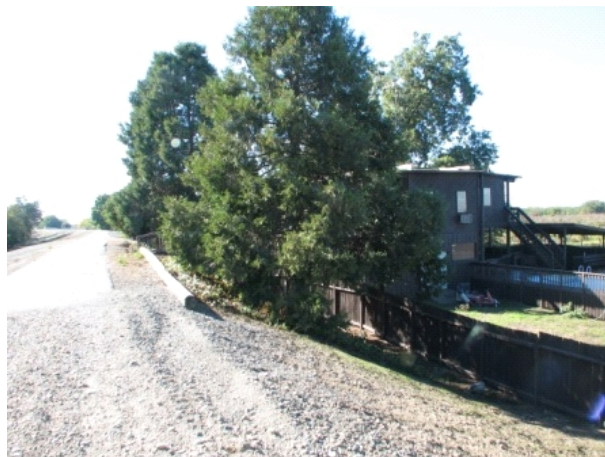
rduffey_f_20101110_283.jpg

Levee Mile Report Line	6
Start Levee Mile	0.45
End Levee Mile	0.49
Location	Land Side
Category	Earthen Levee
Item	Encroachments

Land side levee mile 0.49.

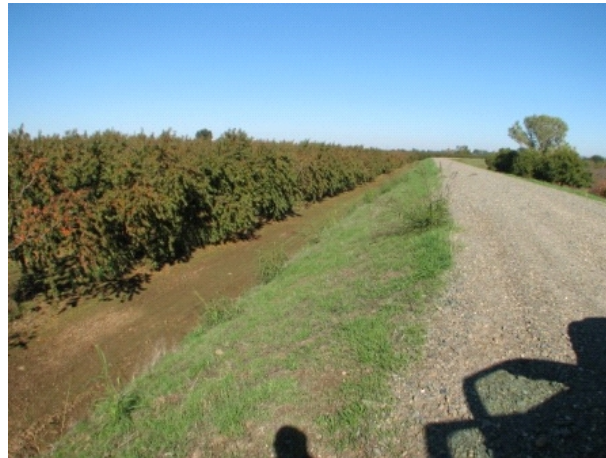
rduffey_f_20101110_284.jpg

Levee Mile Report Line	7
Start Levee Mile	1.45
End Levee Mile	1.82
Location	Land Side
Category	Earthen Levee
Item	Slope Stability

View of slope being disk by farmer.

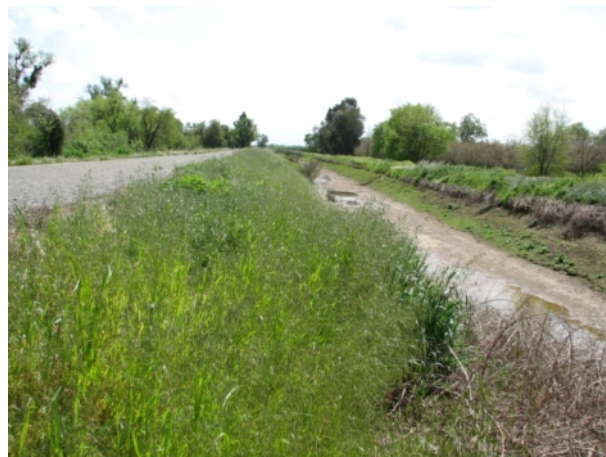
rduffey_f_20101007_200.jpg

Levee Mile Report Line	9
Start Levee Mile	2.85
End Levee Mile	3.08
Location	Land Side
Category	Earthen Levee
Item	Encroachments

Land side ditch levee mile 3.08.

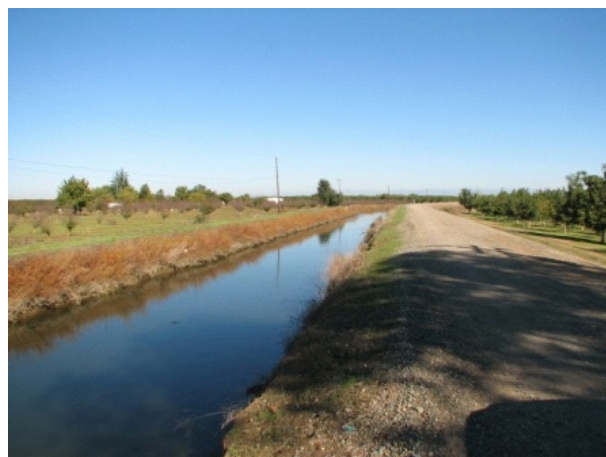
rduffey_f_20101110_285.jpg

Levee Mile Report Line	9
Start Levee Mile	2.85
End Levee Mile	3.08
Location	Land Side
Category	Earthen Levee
Item	Encroachments

AG ditch land side slope and toe.
